MISCELLANEOUS PAPER GL-89-5

STUDY OF EMBANKMENT PERFORMANCE DURING OVERTOPPING AND THROUGHFLOW

Report 1 FEASIBILITY STUDY

Hon-Yim Ko, R. Jeffrey Dunn, Ebrahim Simantob

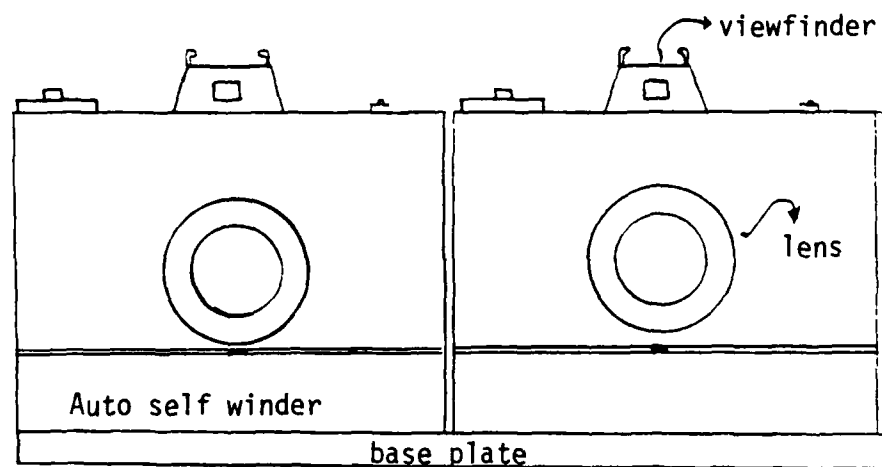
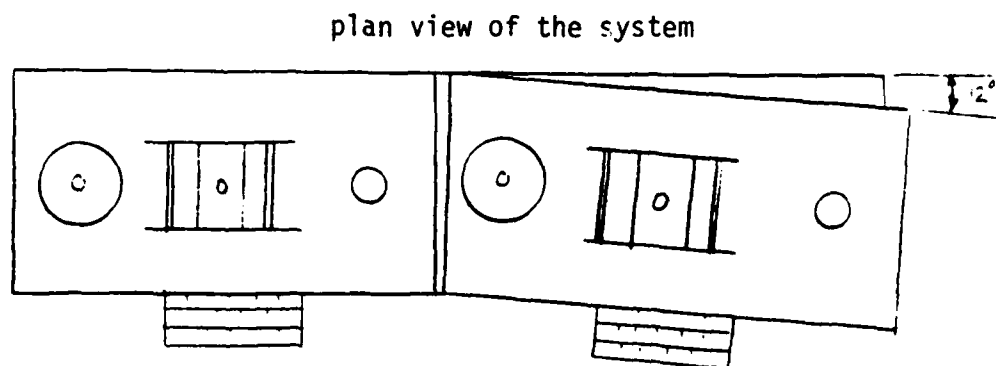
Fig.II.5 Camera system used for stereo photographic measurements

front view of the system

plan view of the system

17. A second 35 mm SLR camera was added to the still photography system, so that stereo pairs could be taken. Different mounting positions were tried. The final configuration adopted is shown in Figure II-5. By putting the two cameras side by side, with one tilted slightly toward the other, nearly complete overlap of the photographs was obtained. Film was advanced by identical self winders, activated through the electrical slip rings, allowing successive photographs to be taken during centrifuge operation.

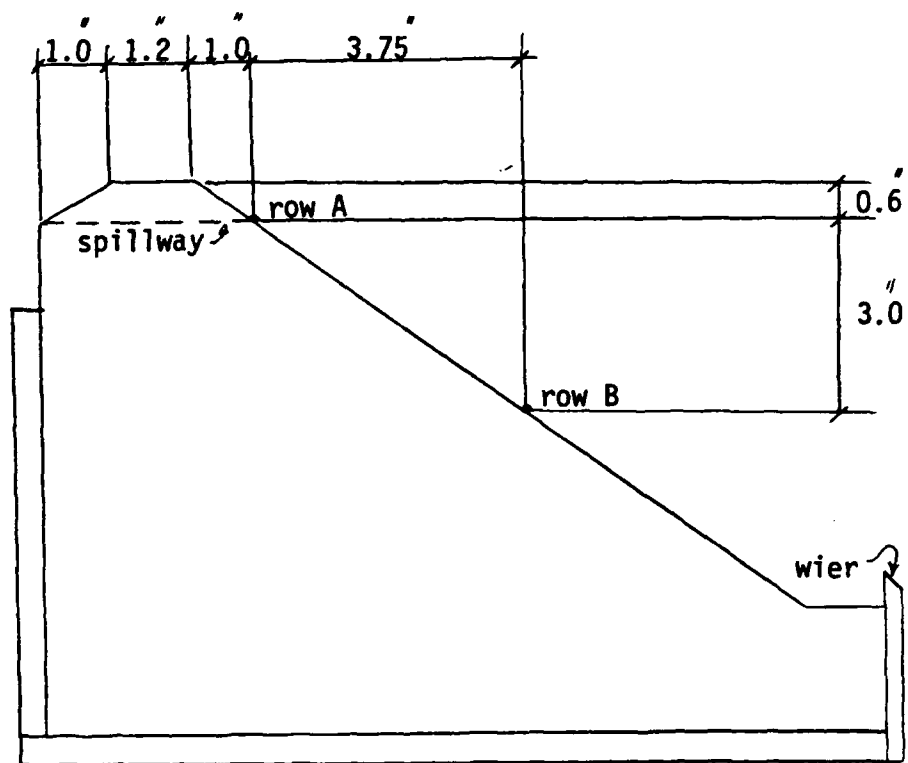
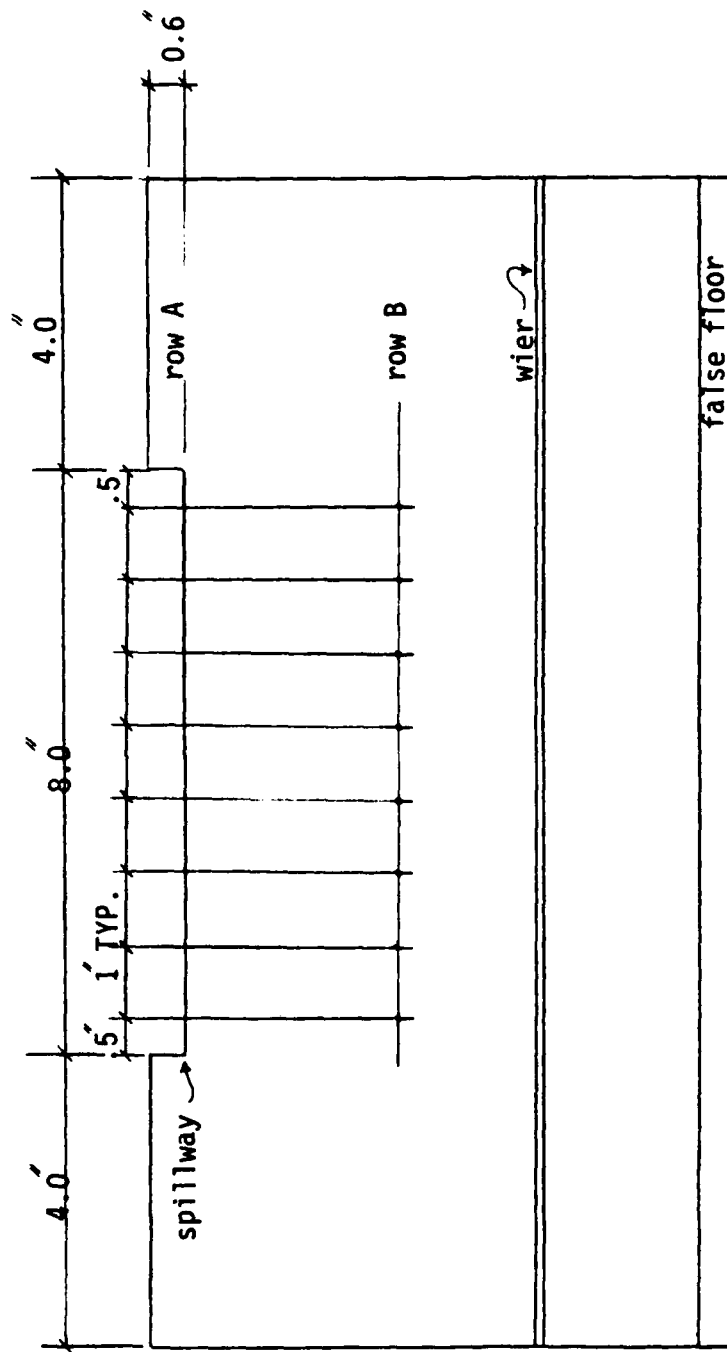
Fig.II.6 Manual measurement locations for crushed rock embankments, (a) Side view

Fig.II.6 Manual measurement locations for crushed rock embankments,
(b) Front view

- a. Make preliminary measurements of two surface cross-sections using a hand-held machinists scale at the locations shown in Figures II-6 or II-7.
- b. Photograph surface of embankment using twin 35mm SLR cameras to obtain preliminary, or before overtopping, view of embankment.
- c. Start video tape recorder to record test.

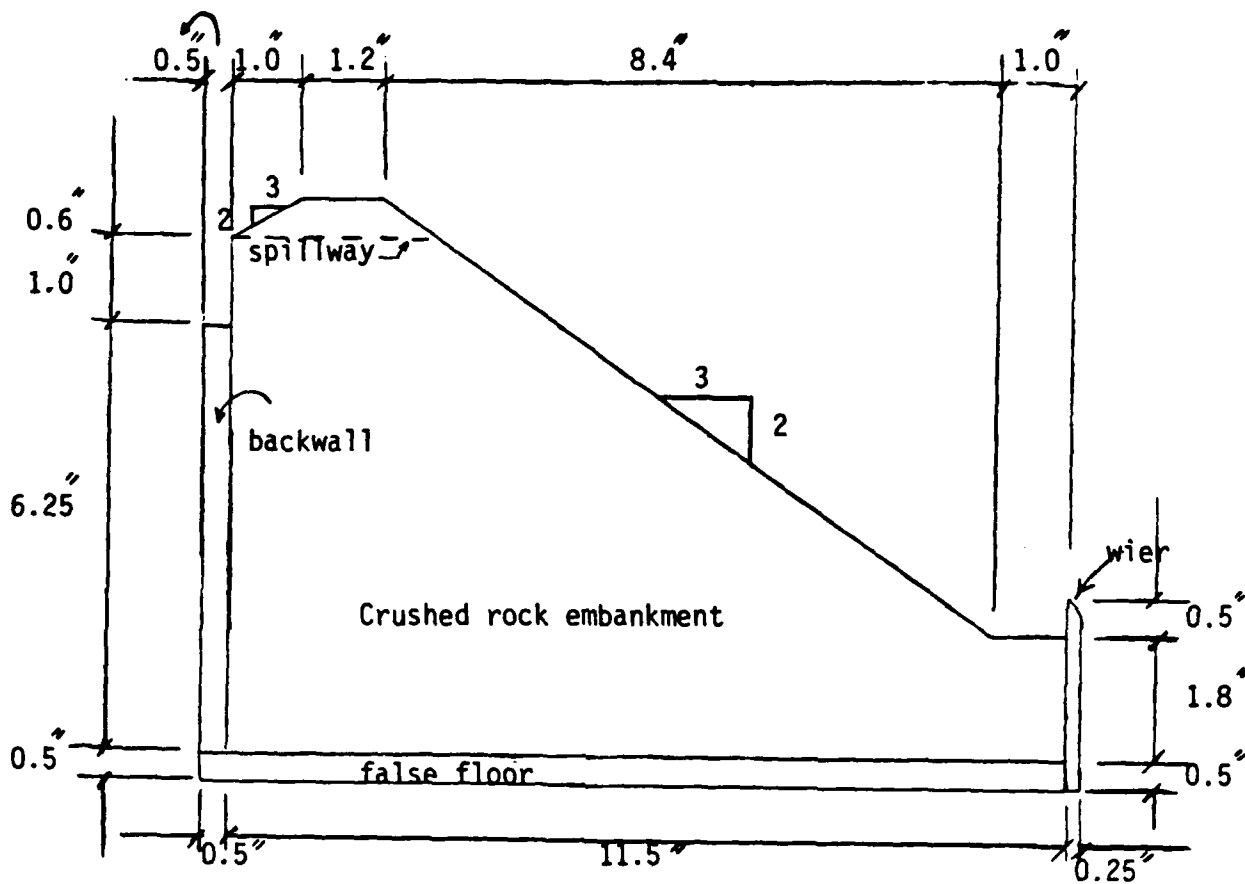
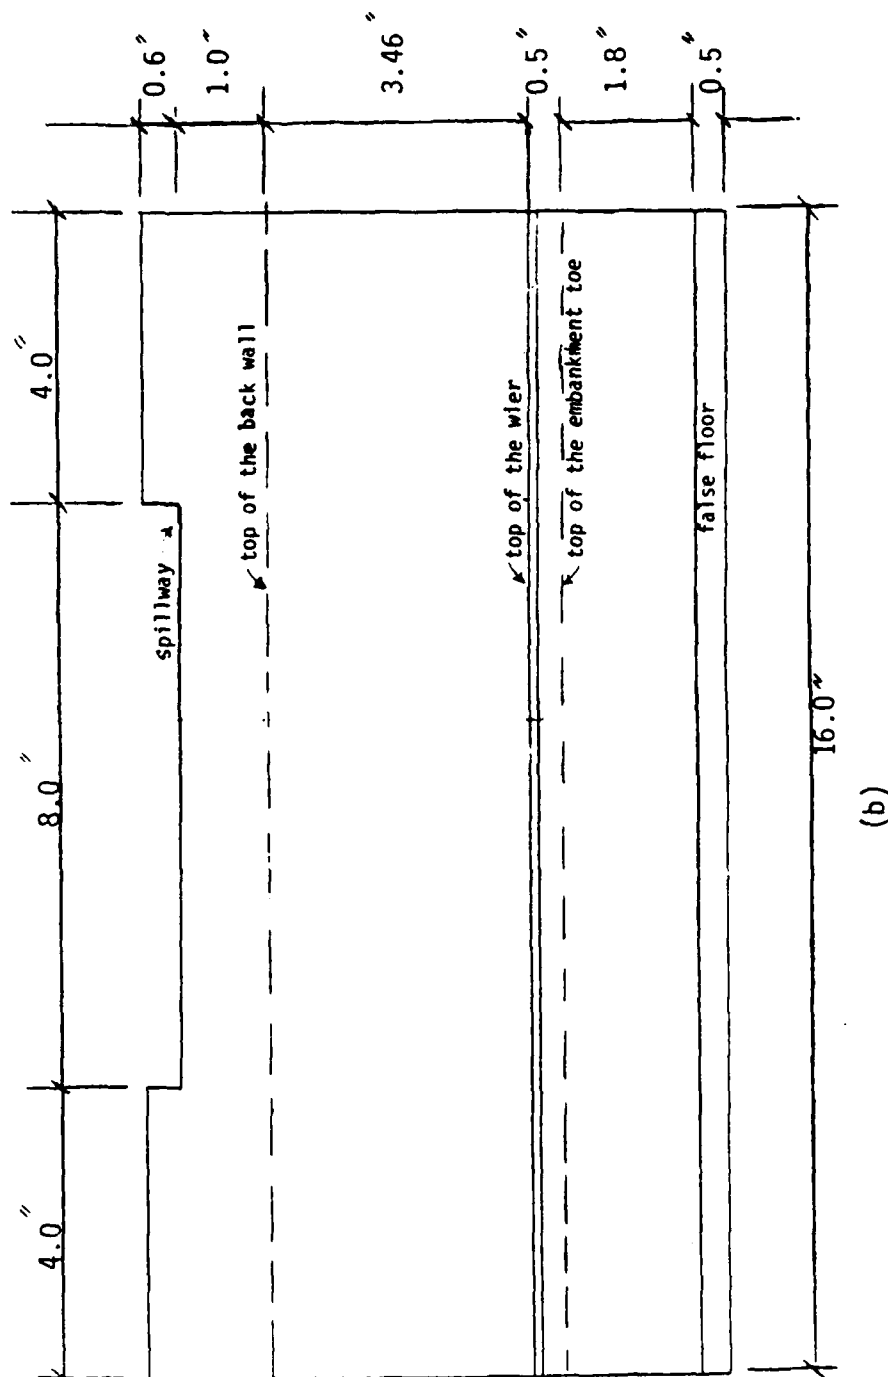
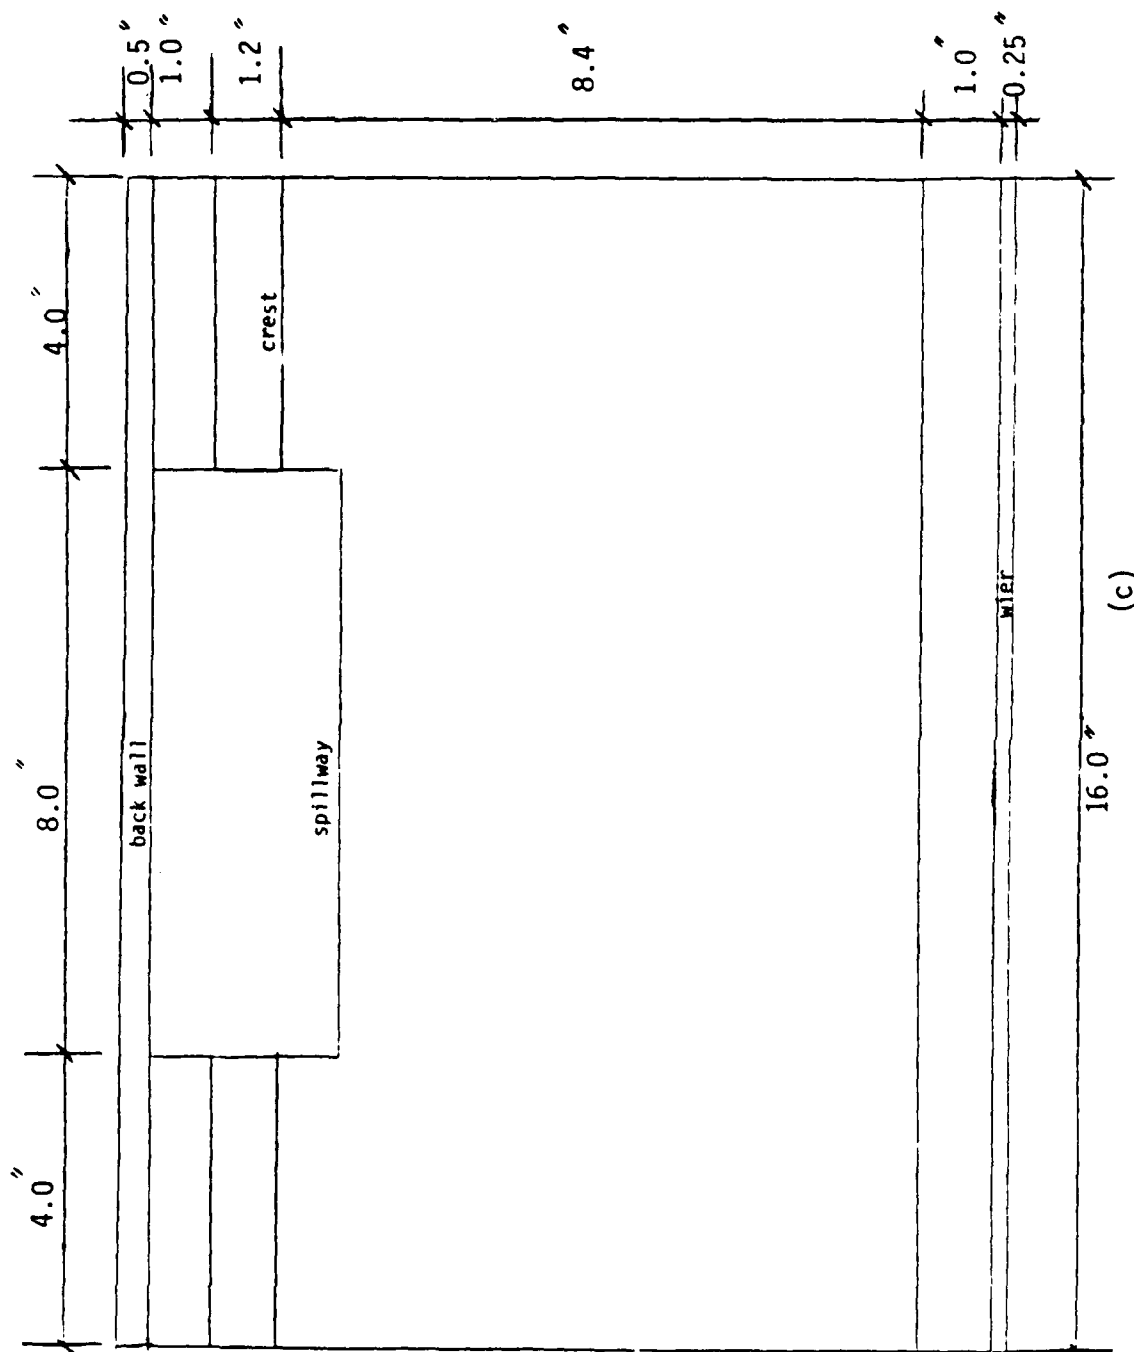
Fig. III.5 Crushed rock embankment configuration, (a) Side view

Fig. III.5 Crushed rock embankment configuration, (b) Front view

Fig.III.5 Crushed rock embankment configuration: (c) Plan view

30. Embankment slopes and the spillway were then carefully trimmed to the configuration shown in Figure III-5 using soil spatulas and a small cement trowel. The 0.5 inch high, 16 inch long weir, used to develop a tailwater was installed at the downstream end of the

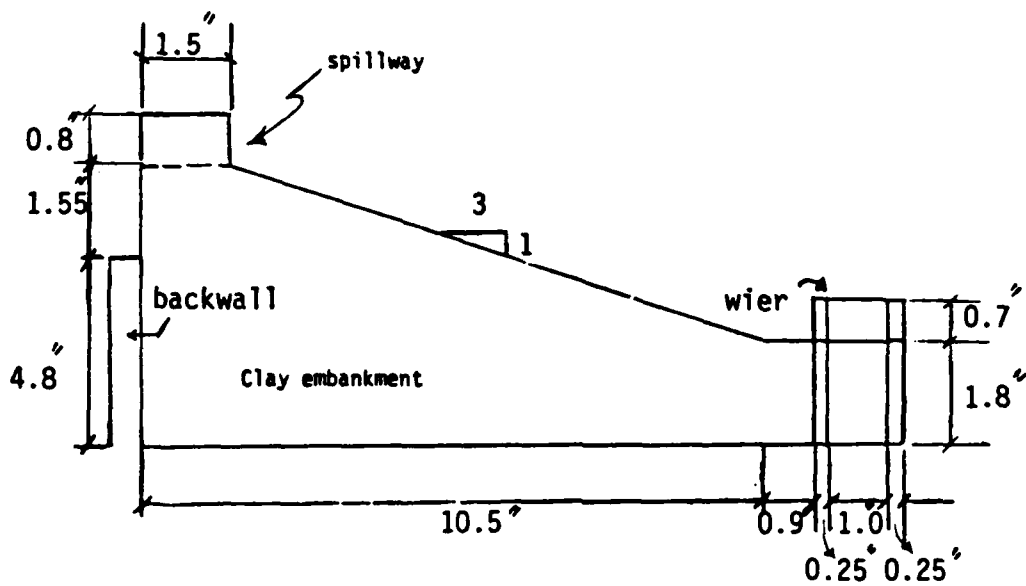
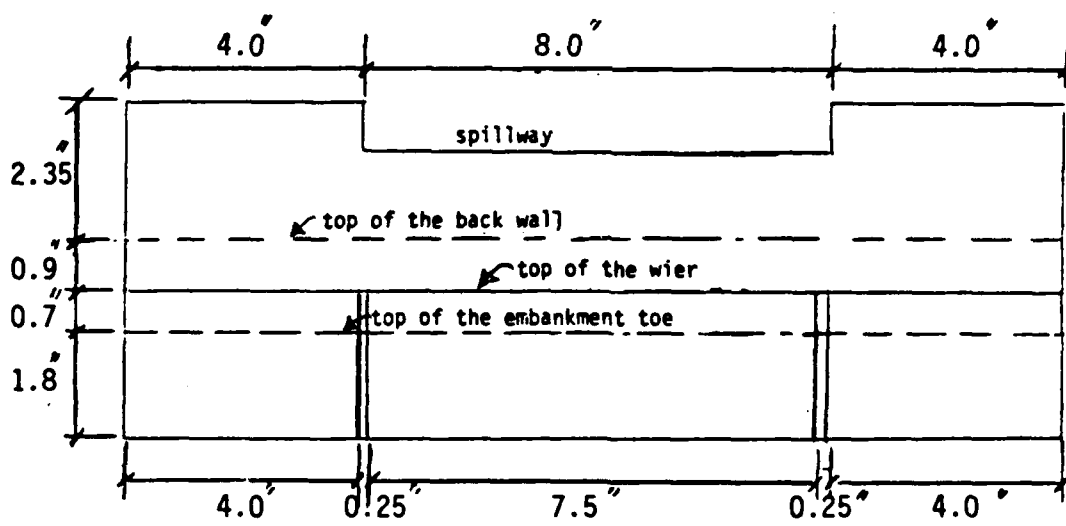
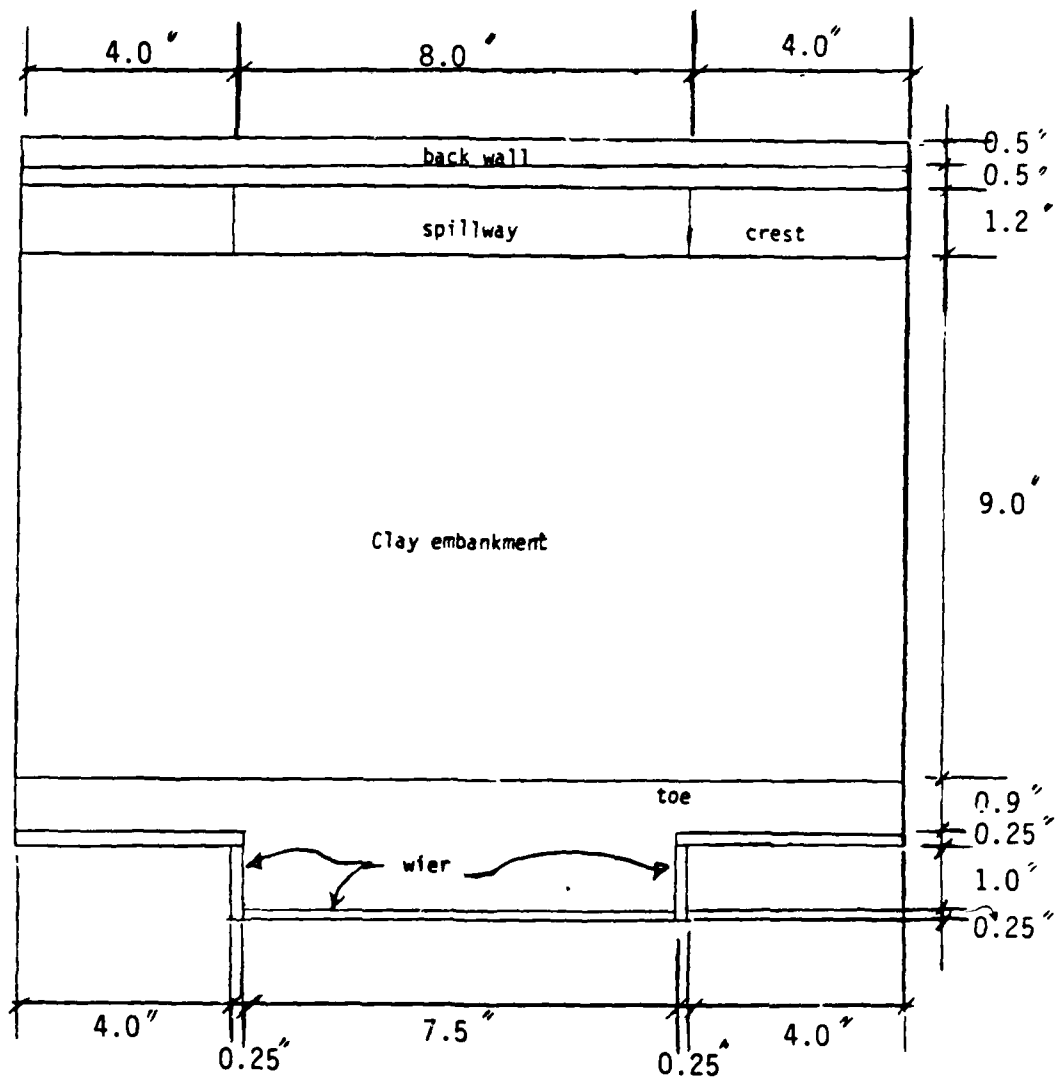
Fig.III.6 Clay embankment configuration, (a) Side view, (b) Front view

Fig.III.6 Clay embankment configuration, (c) Plan view

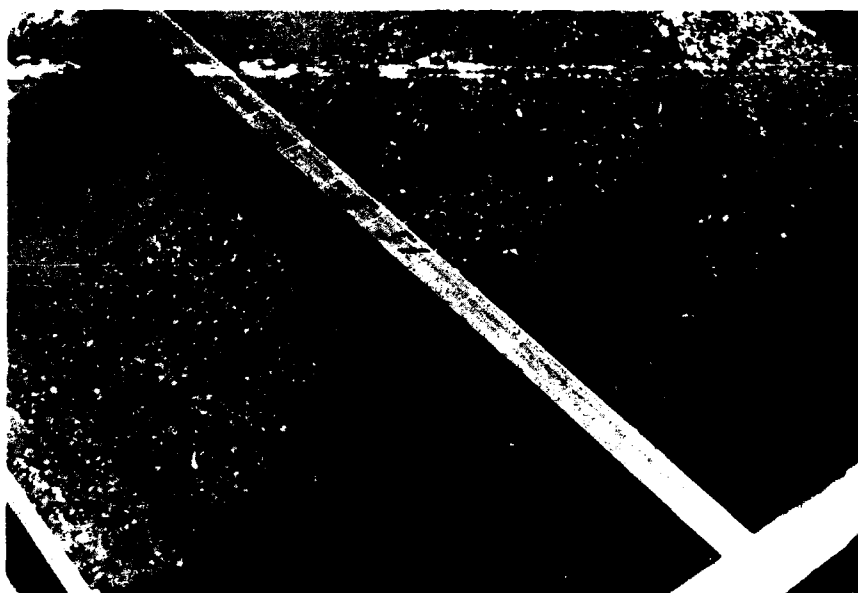
Fig. V.2 Photographs of crushed rock embankment S-2 after completion of approximately 16 seconds of overtopping
(a) Top view, (b) Front view

Fig. V.2 Photographs of crushed rock embankment S-2 after completion of approximately 16 seconds of overtopping, (c) and (d) Downstream slope

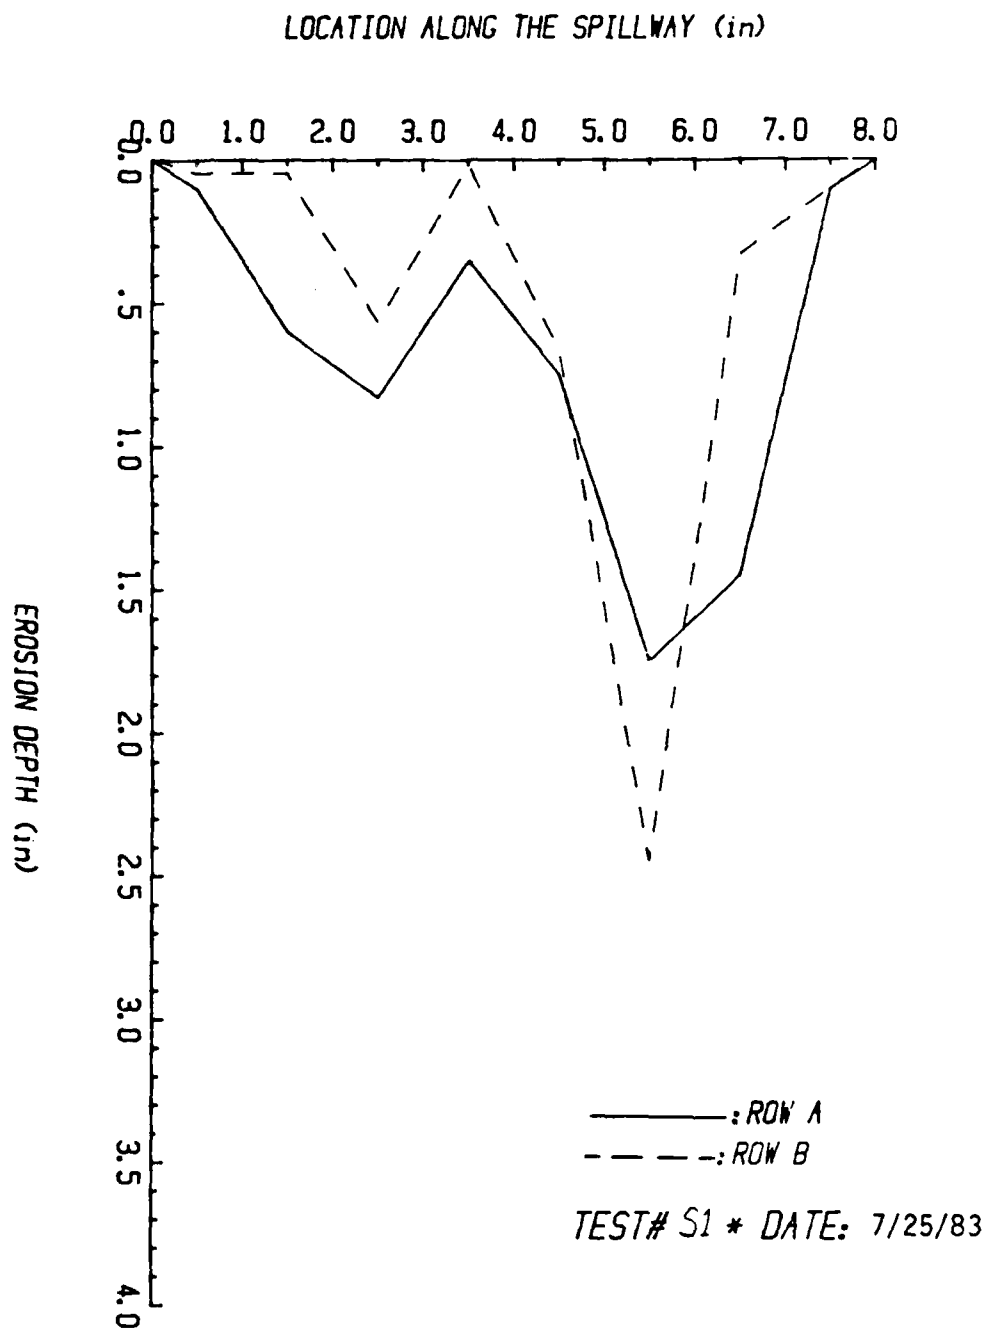
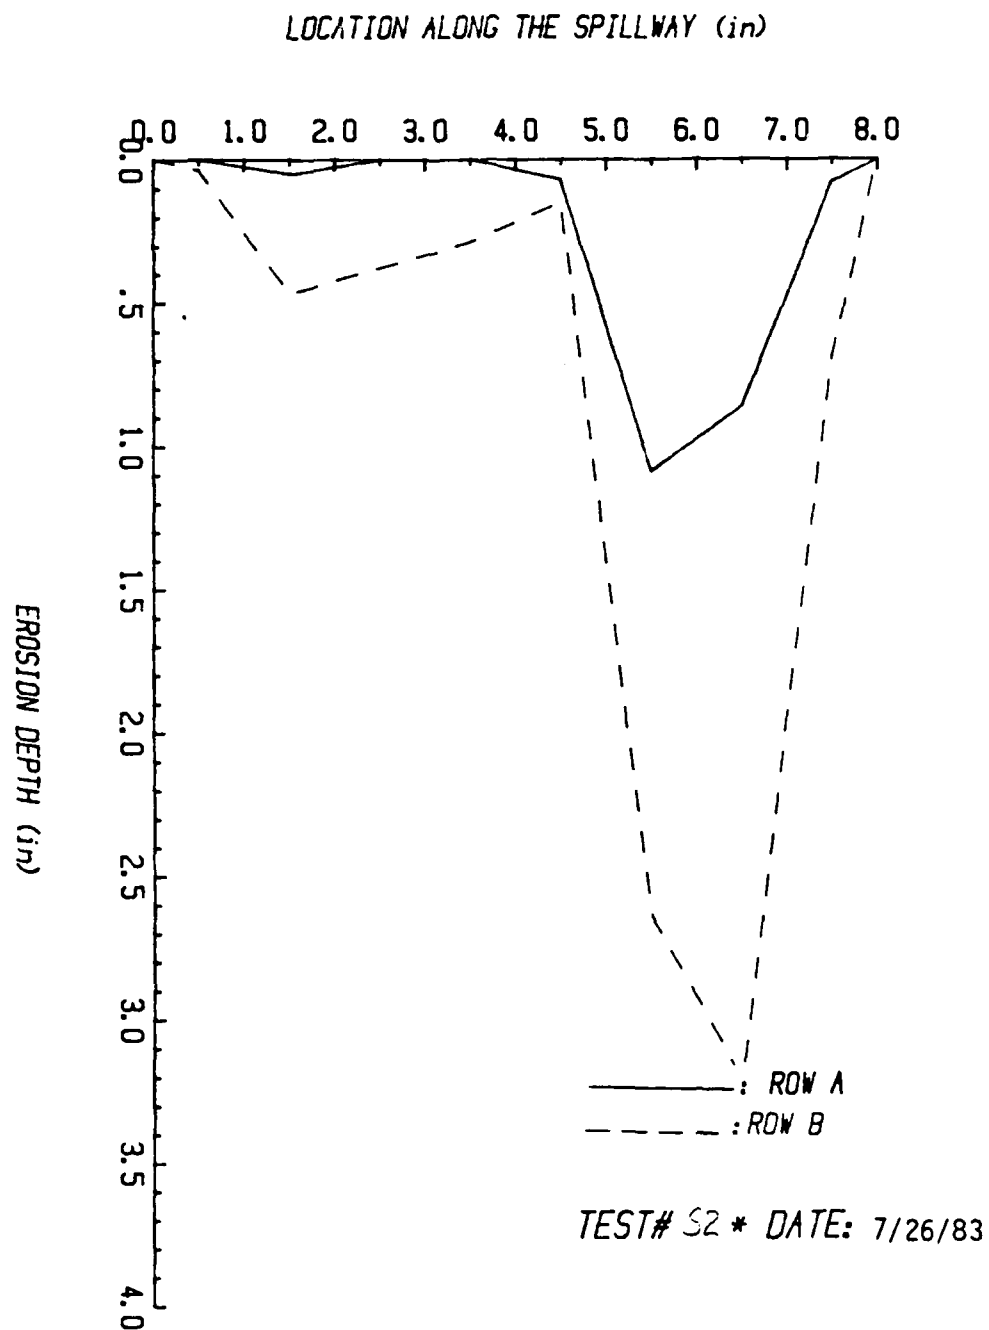
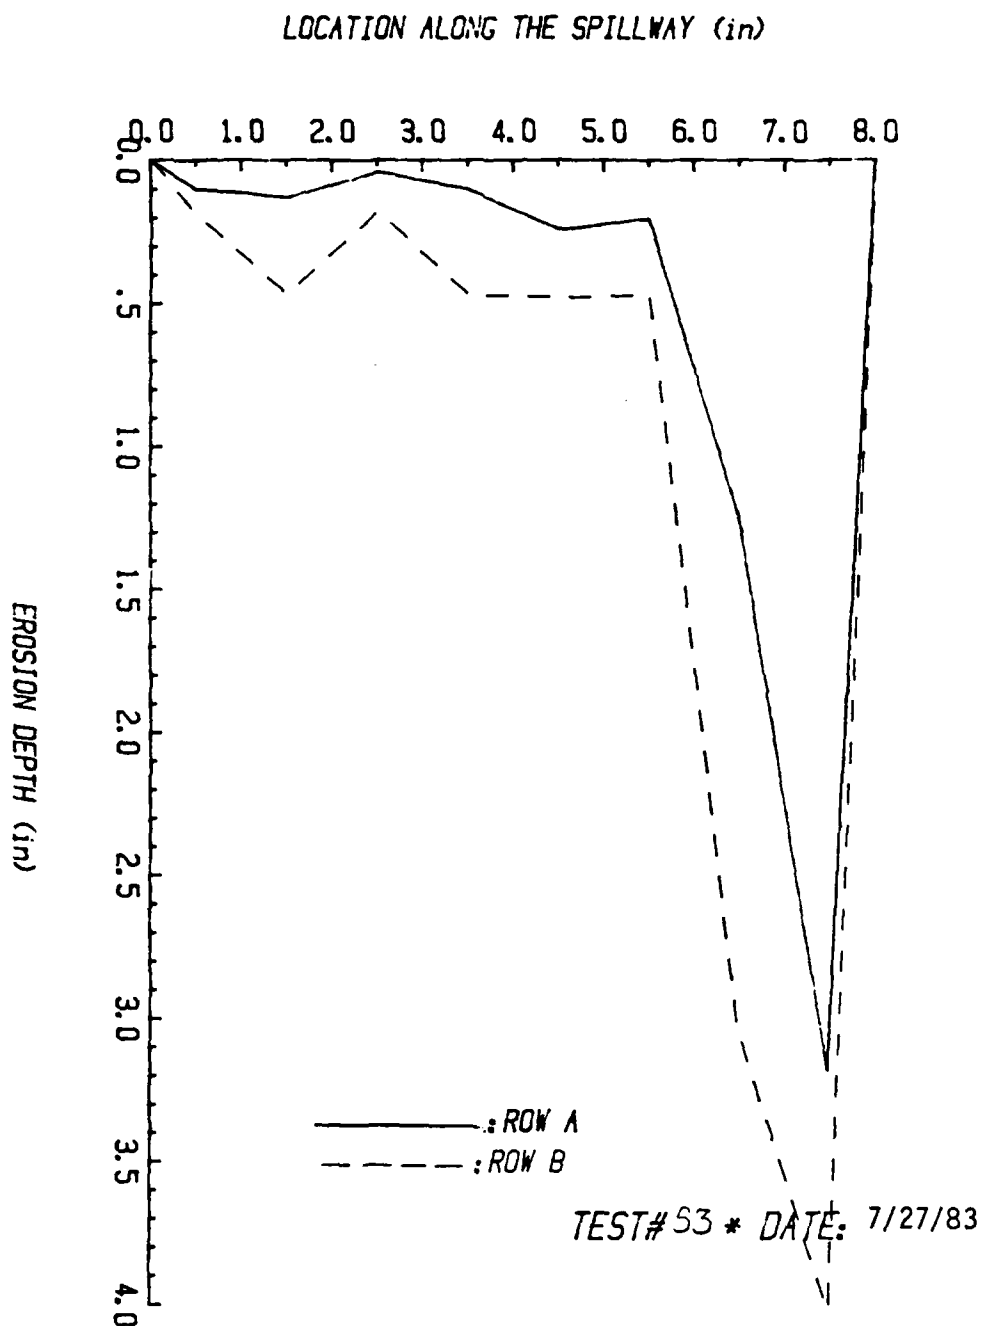
Fig. V.3 (a) Erosion profile cross sections of crushed rock embankment S-1 determined from manual measurements

Fig. V.3 (b) Erosion profile cross sections of crushed rock embankment S-2 determined from manual measurements

Fig. V.3 (c) Erosion profile cross sections of crushed rock embankment S-3 determined from manual measurements

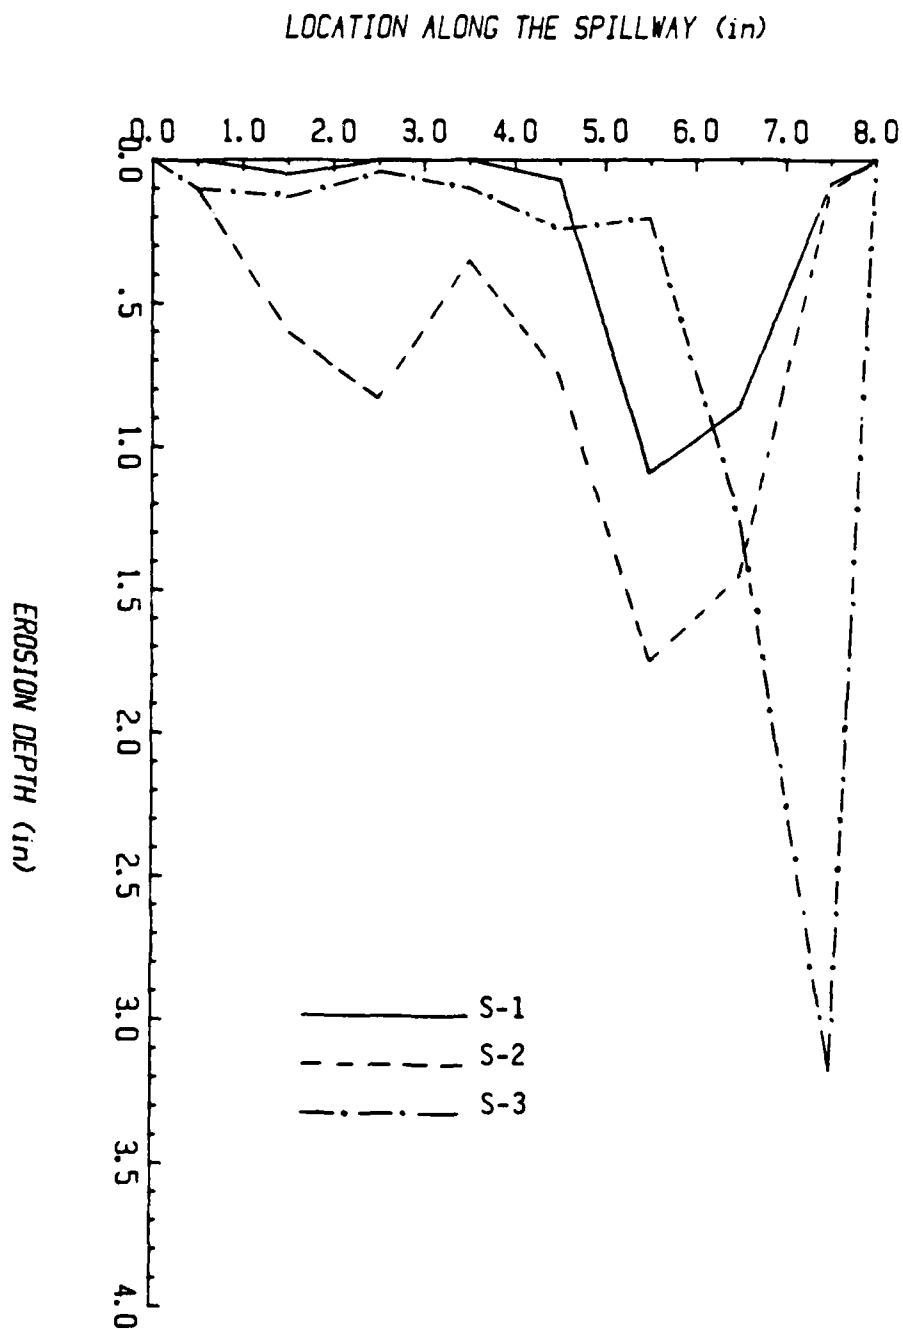
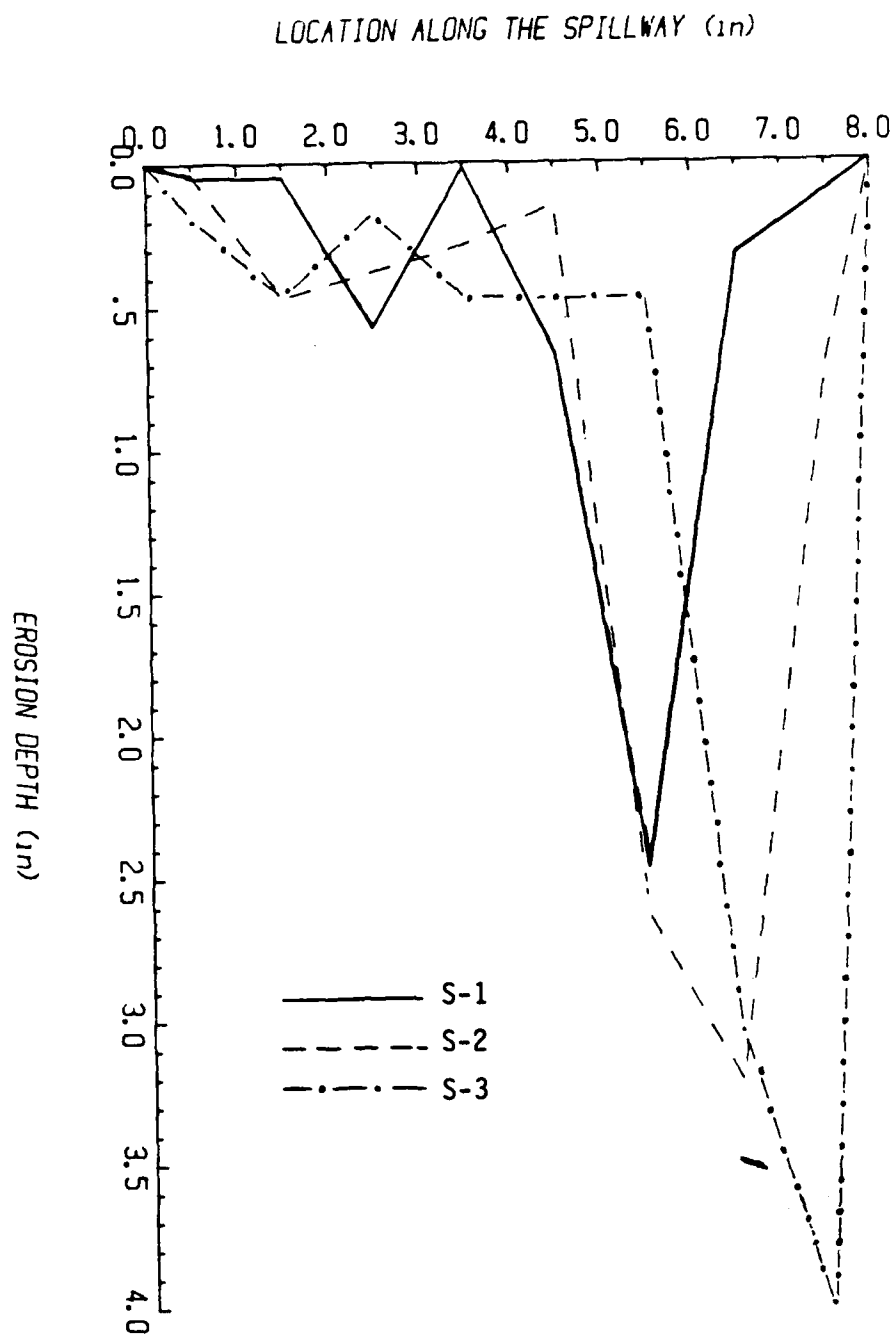
Fig. V.4 (a) Comparison of crushed rock embankment erosion profile cross sections at row A determined from manual measurements

Fig. V.4 (b) Comparison of crushed rock embankment erosion profile cross sections at row B determined from manual measurements

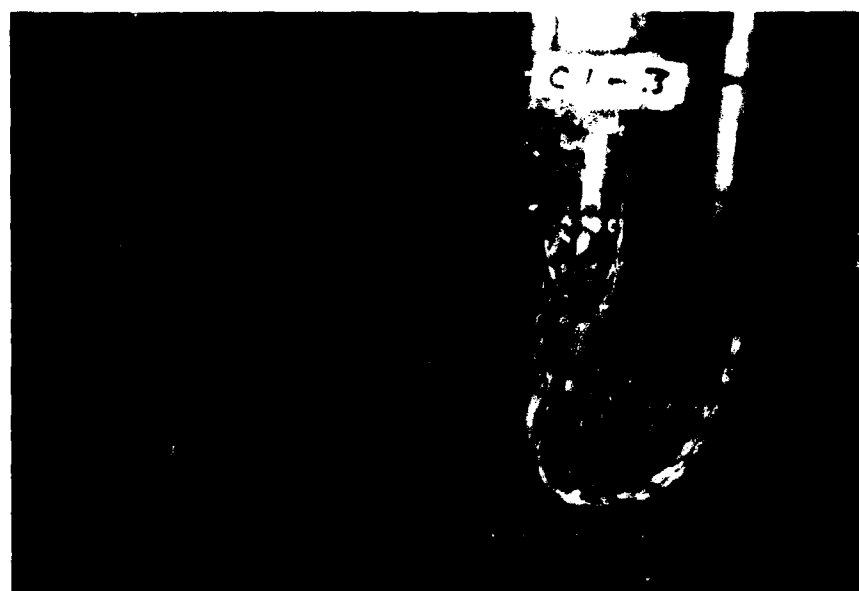
Fig. V.5 (d) Stereo photographs of clay embankment C-1
after 12 minutes of overtopping

Fig. V.5 (e) Stereo photographs of clay embankment C-1
after 16 minutes of overtopping

40. As indicated previously, the clay embankments did not fail after 16 minutes of overtopping flow. In Figure V-5 stereophotos of Sample C-1, taken at successive 4 minute intervals, are presented. The photos indicate that erosion occurred over the entire area below the spillway. The erosion profile was a wide U-shaped, moderately sloped channel, containing several ridges. This erosion profile agrees with the discussion of erosion gully shapes in different soil types presented by Winterkorn and Fang (1975). Photographs of the three clay embankments after completion of the tests are shown in Figure V-6 and show the similarity of the erosion profile between the tests.

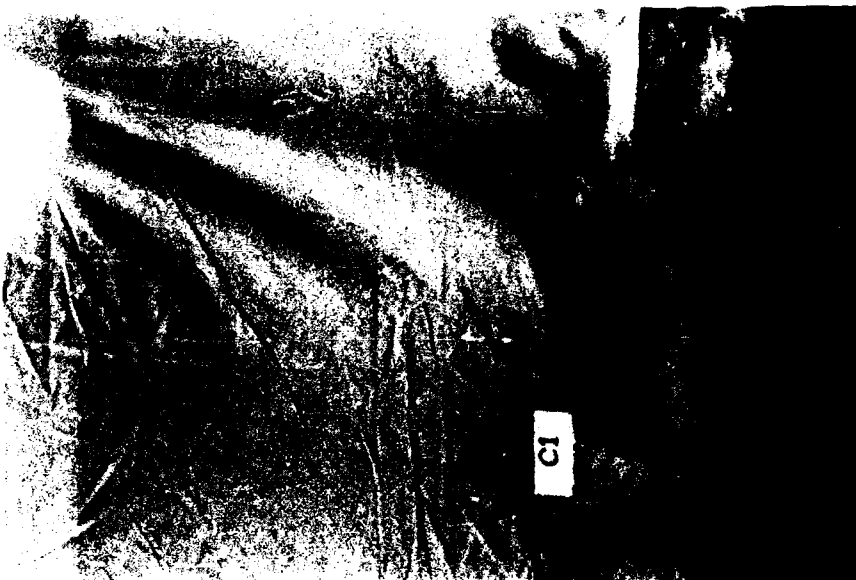
Fig. V.6 Photographs of clay embankments after completion of 16 minutes of overtopping, (a) Embankment C-1, (b) Embankment C-2

Fig.V.6 Photographs of clay embankments after completion of 16 minutes of overtopping, (c) Embankment C-3, (d) Embankments C-1, C-2, C-3
